Intel[®] Mobile Celeron[™] Processor at 466 MHz, 433 MHz, 400 MHz, 366 MHz, 333 MHz, 300 MHz, and 266 MHz Specification Update

Release Date July 2000

Order Number: 244444-016

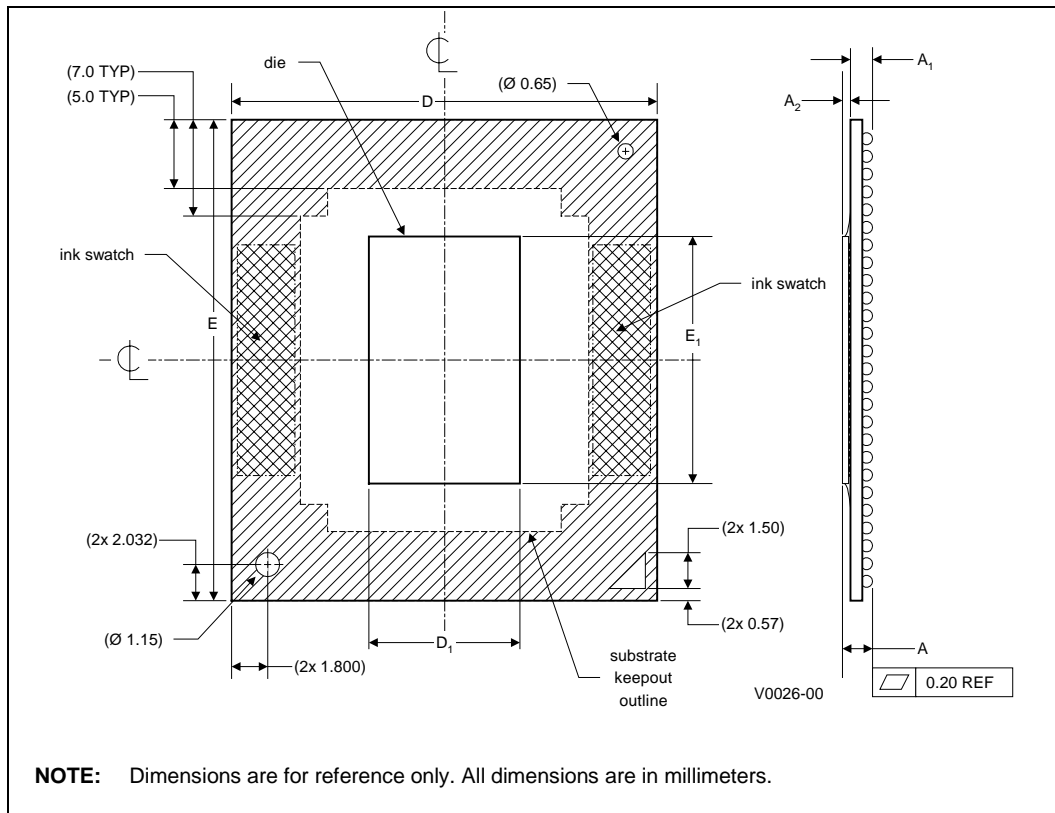
Figure 5.3. Surface-Mount BGA1 Package—Top and Side View

The following table and figures show the updated mechanical specifications for the BGA1 package, listed as Table 5.2, Figure 5.3 and 5.4, respectively, in the *Intel® Mobile Celeron™ Processor in BGA Package at 333 MHz, 300 MHz and 266 MHz* datasheet.

1. The number shown here is different from that in the 244444-004 version of this specification update. The maximum reference number is used.
